**50 Years Later – The
Legacy of the 1964
Flood in the Redwood
Creek Watershed**

Mary Ann Madej, USGS-WERC

Long-Term Legacy of the 1964 Flood

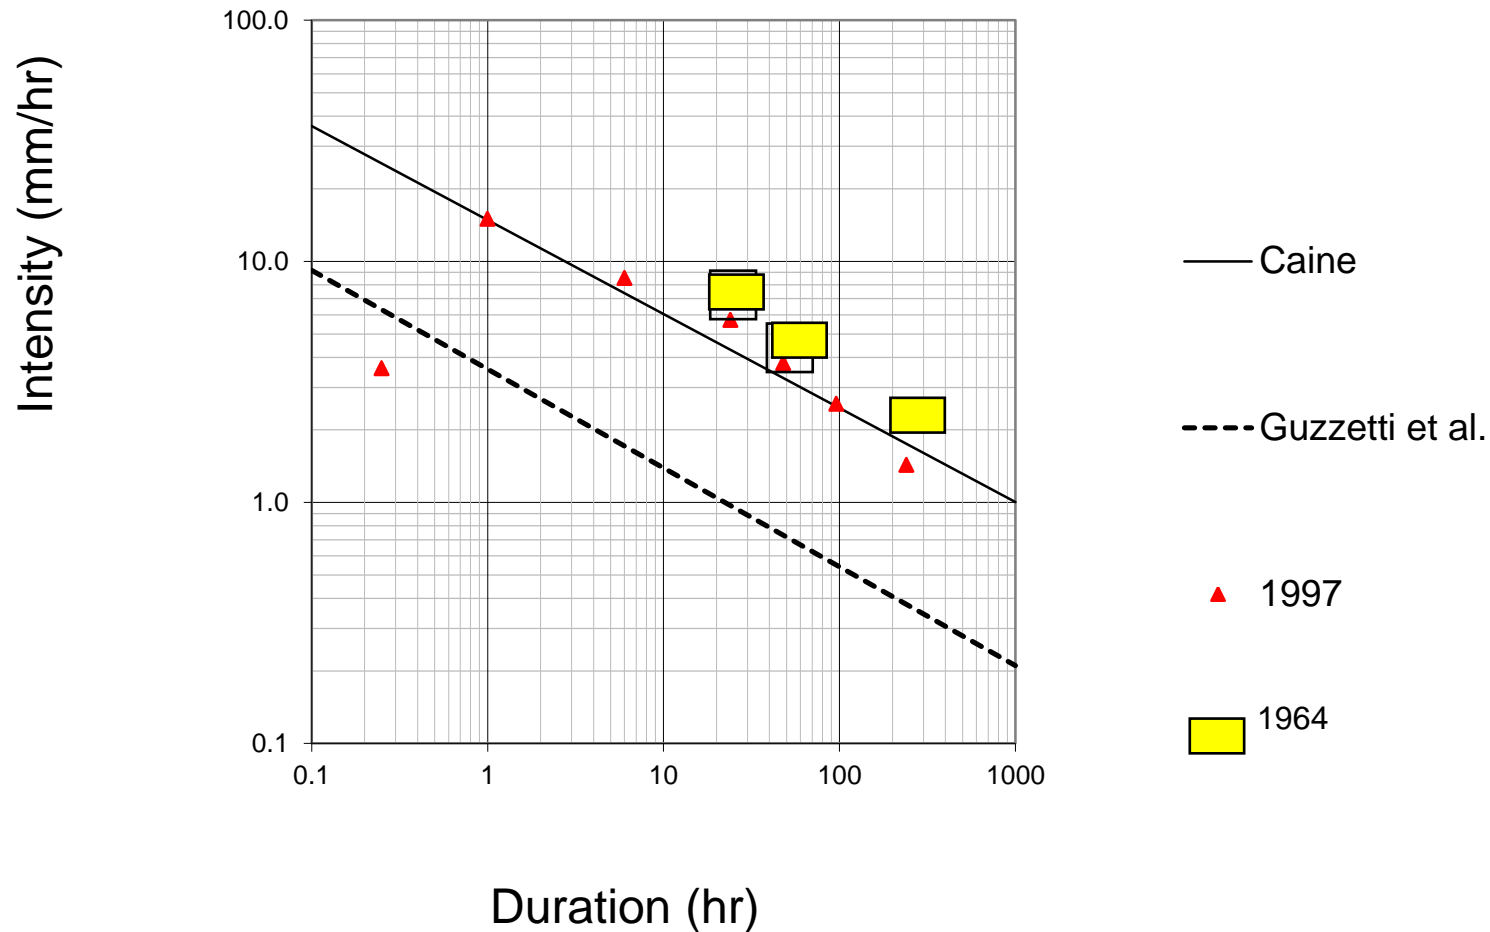
Landslide Thresholds: Rainfall Duration-Intensity

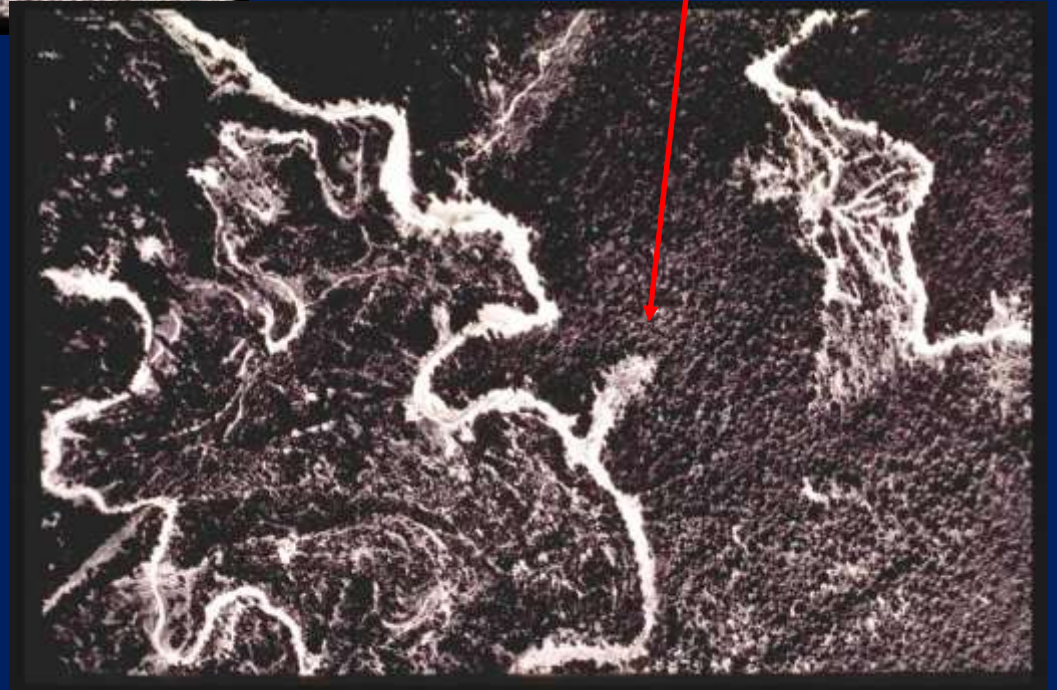
Air photo mapping of
landslide scars

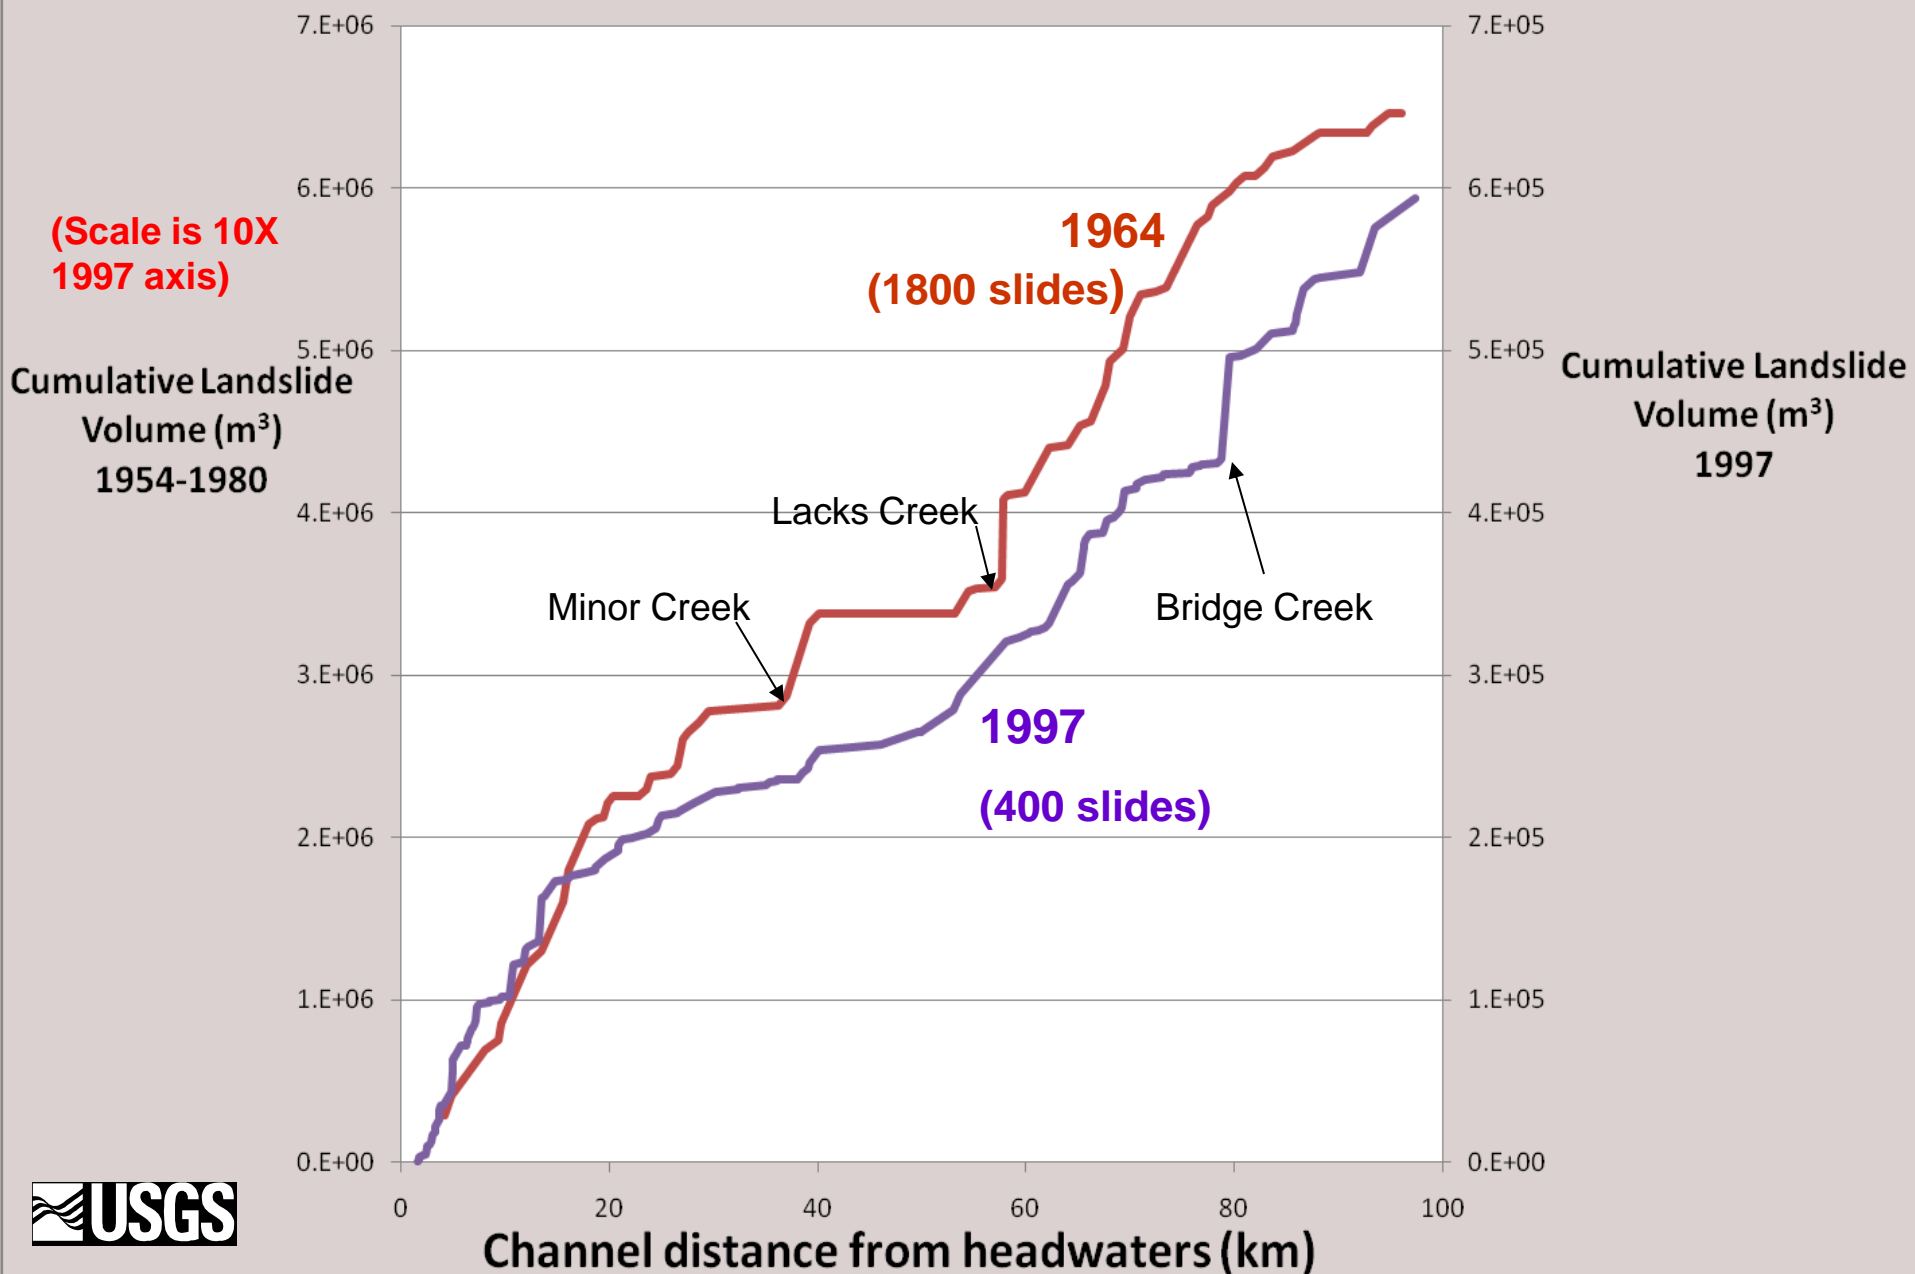
Cumulative Landslide Volume vs. Channel Distance

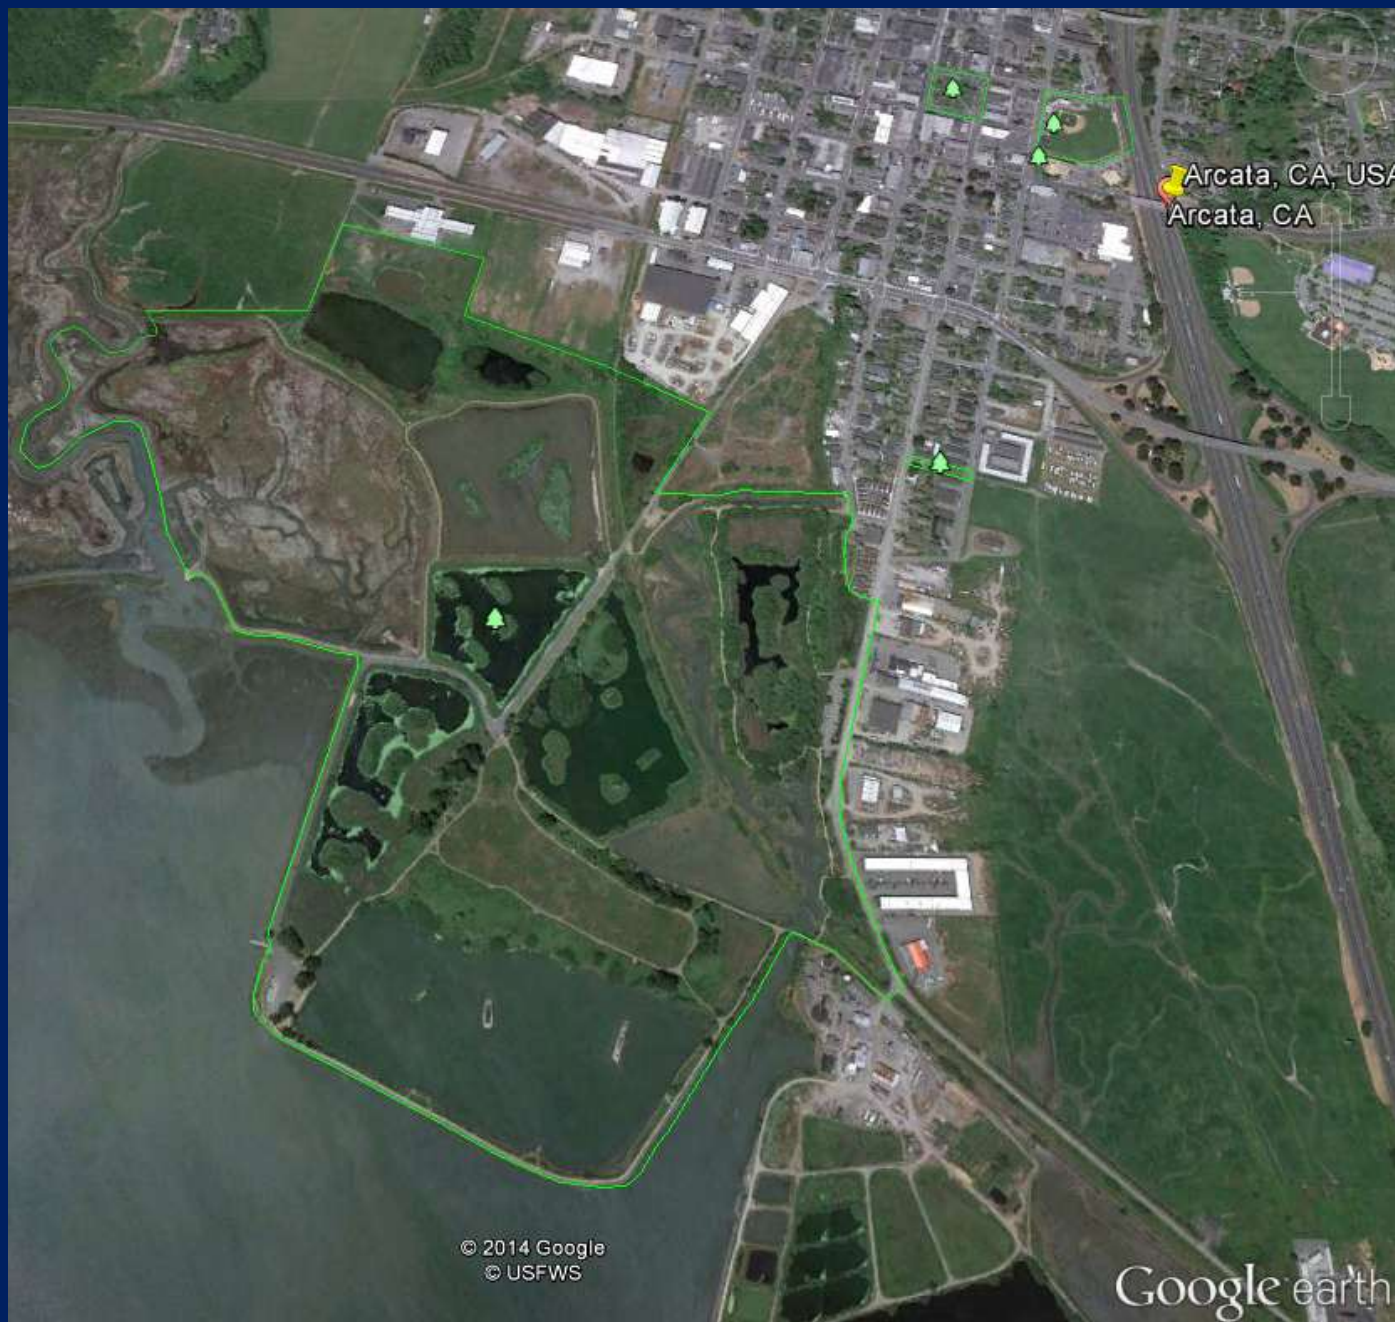
Arcata
Marsh:
307 acres-

Covered
by 5 m of
sediment

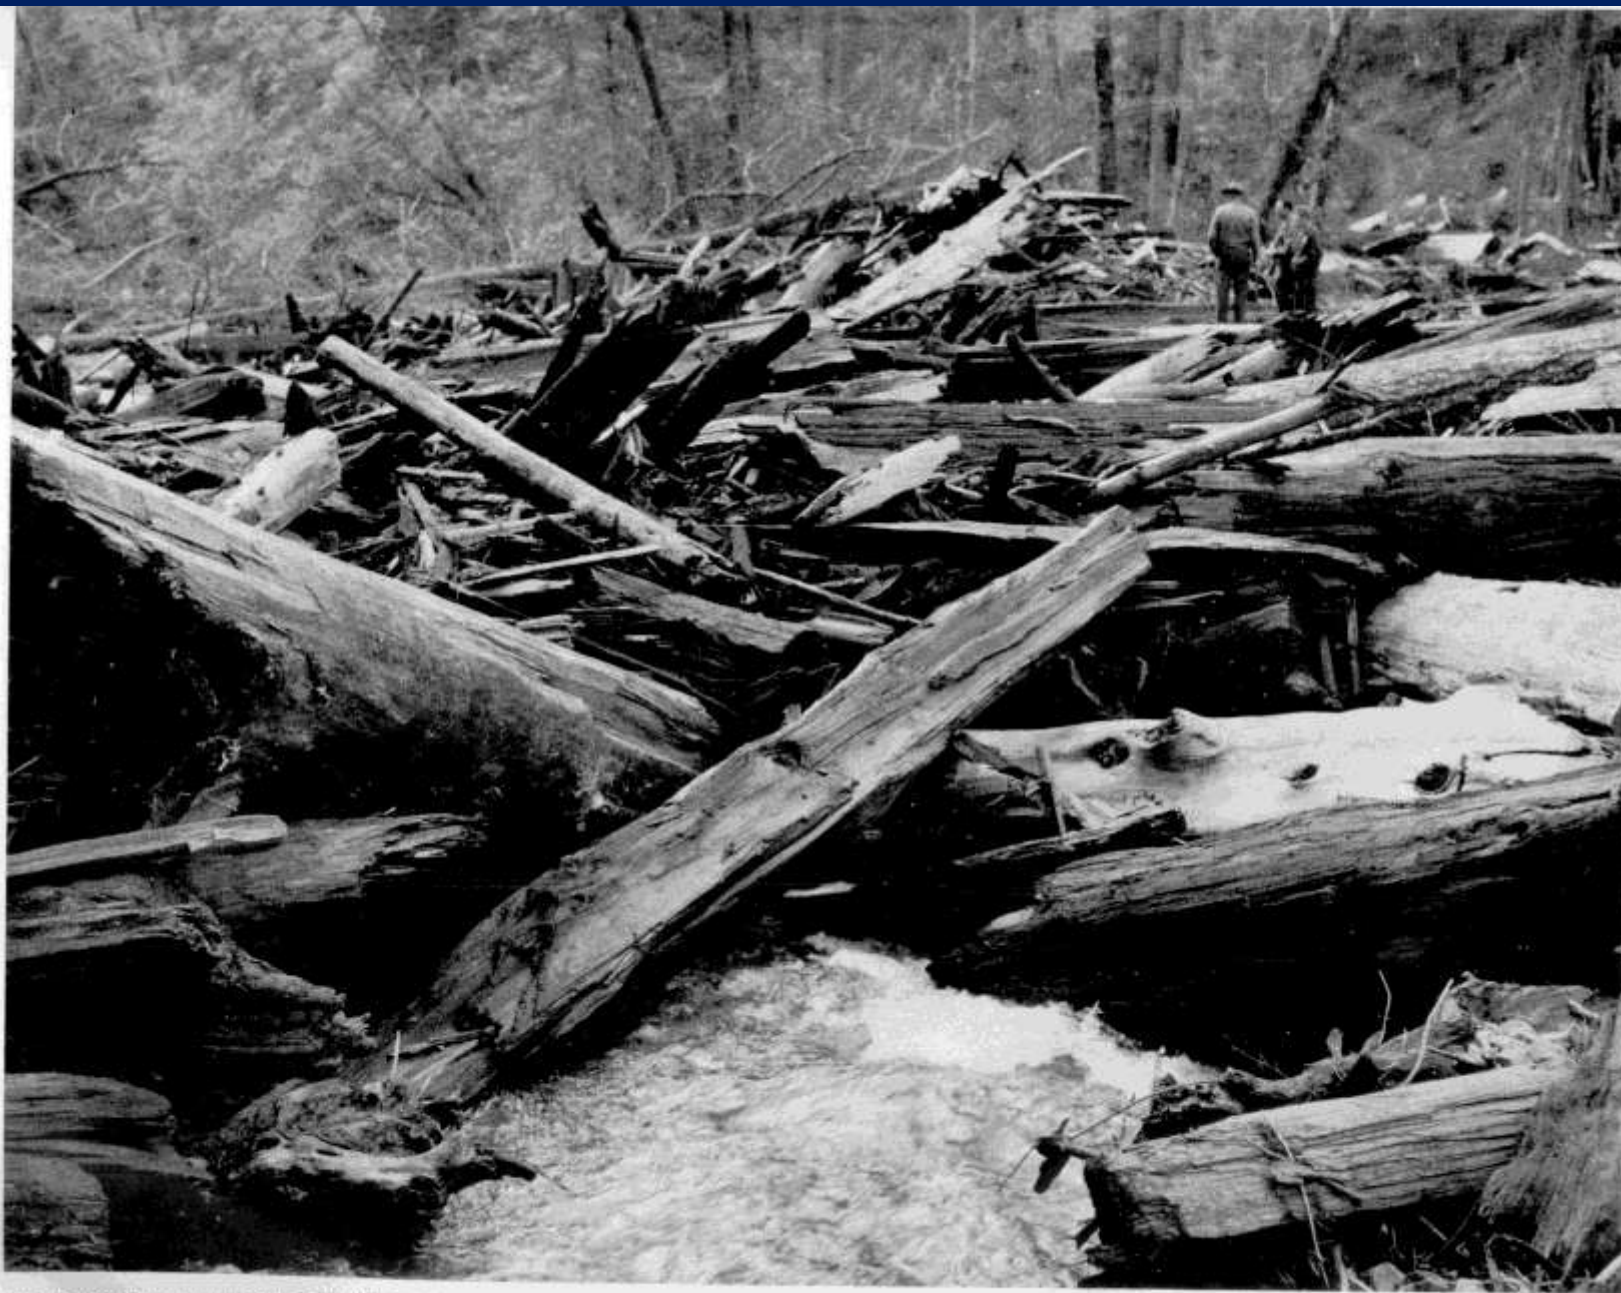
HUNTER CREEK, HUMBOLDT COUNTY, Feb. 14, 1956. Heavy 1955-56 winter rains and resulting December and January floods failed to move this jam which extends about 300 yards downstream and completely blocks the passage of migrating fish. (Fish and Game photo.)

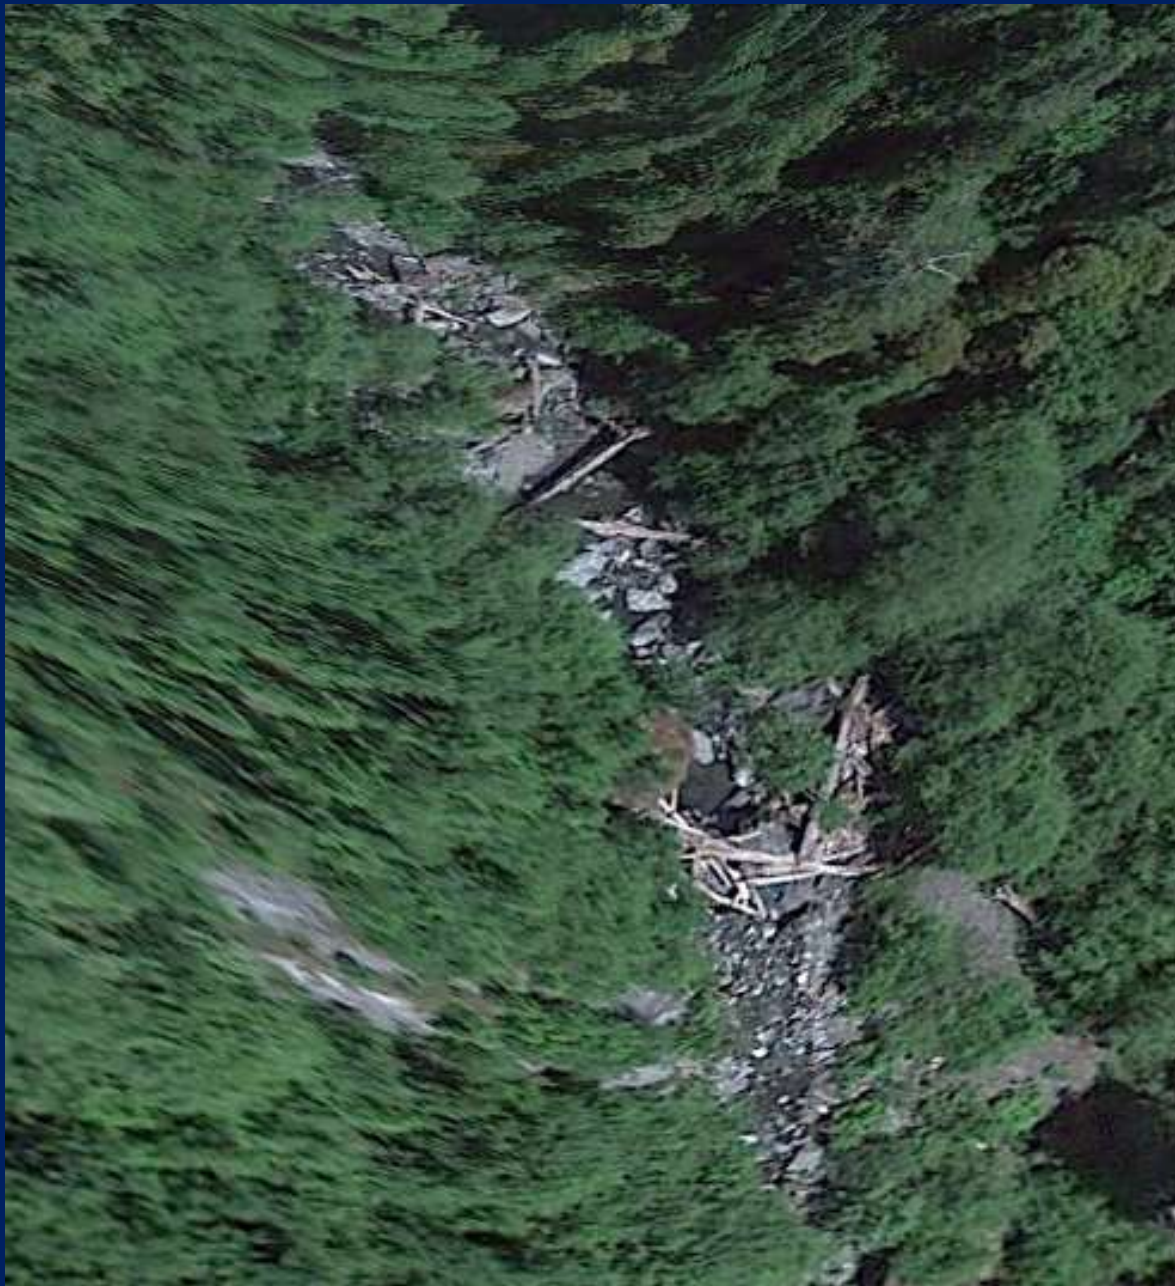
Log jams store sediment, releasing it as the jams decay over time.

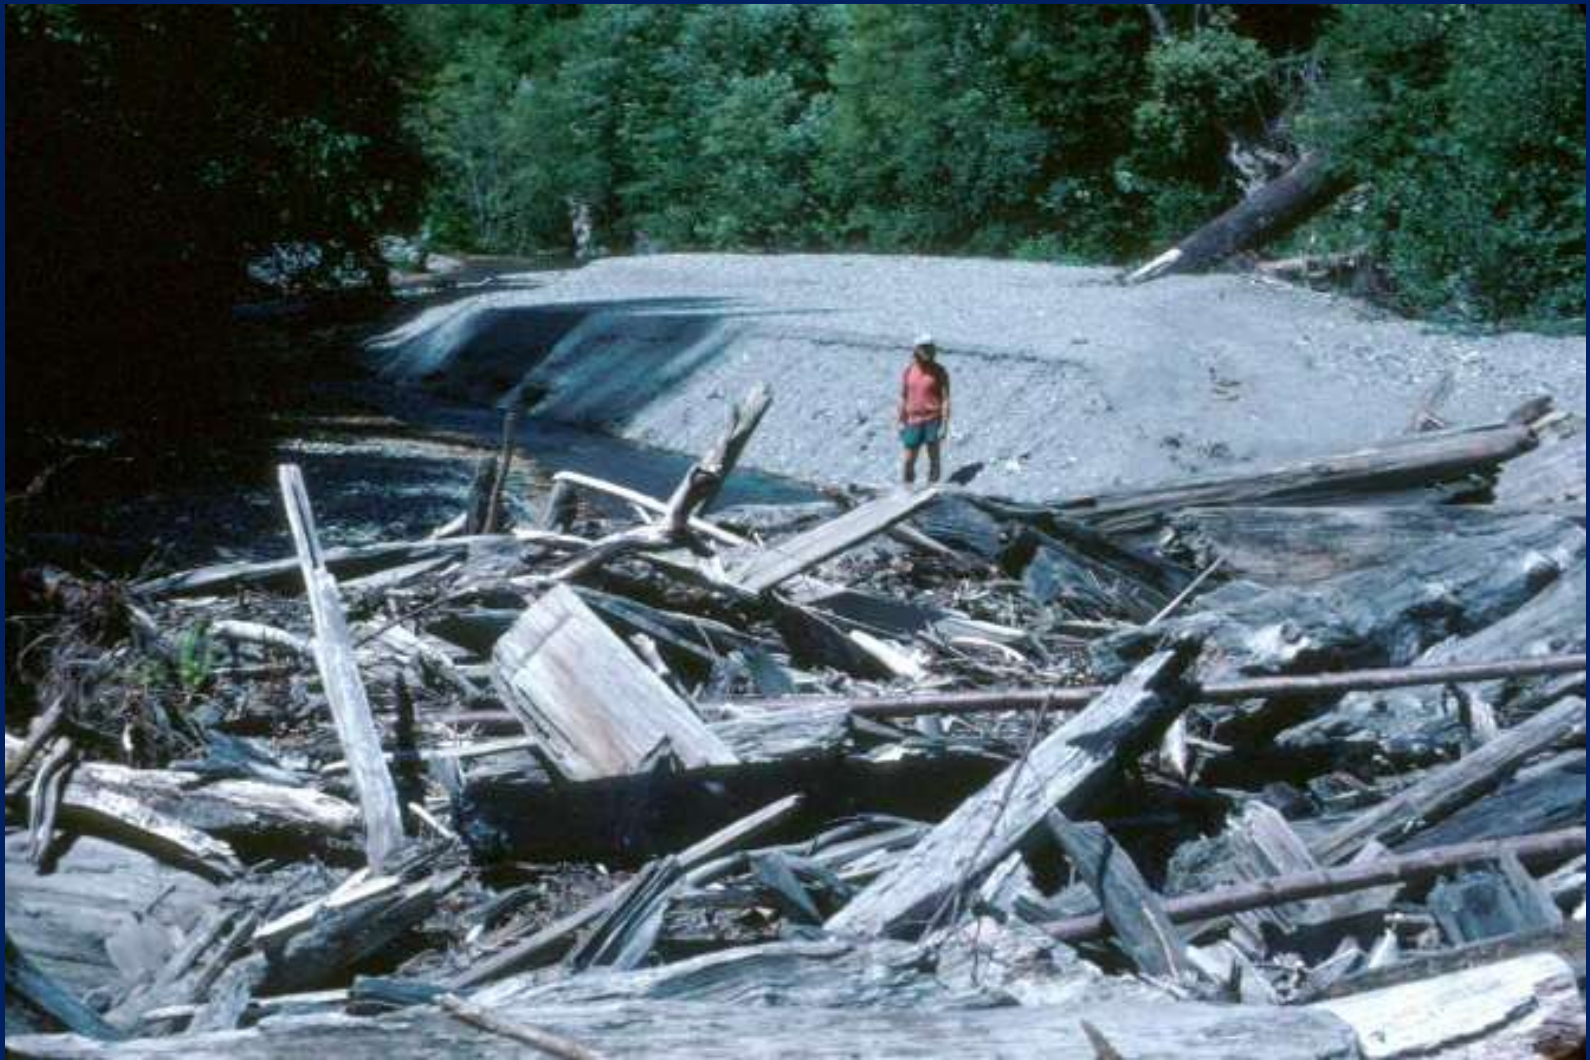
Log jam on Van Duzen River, 1964

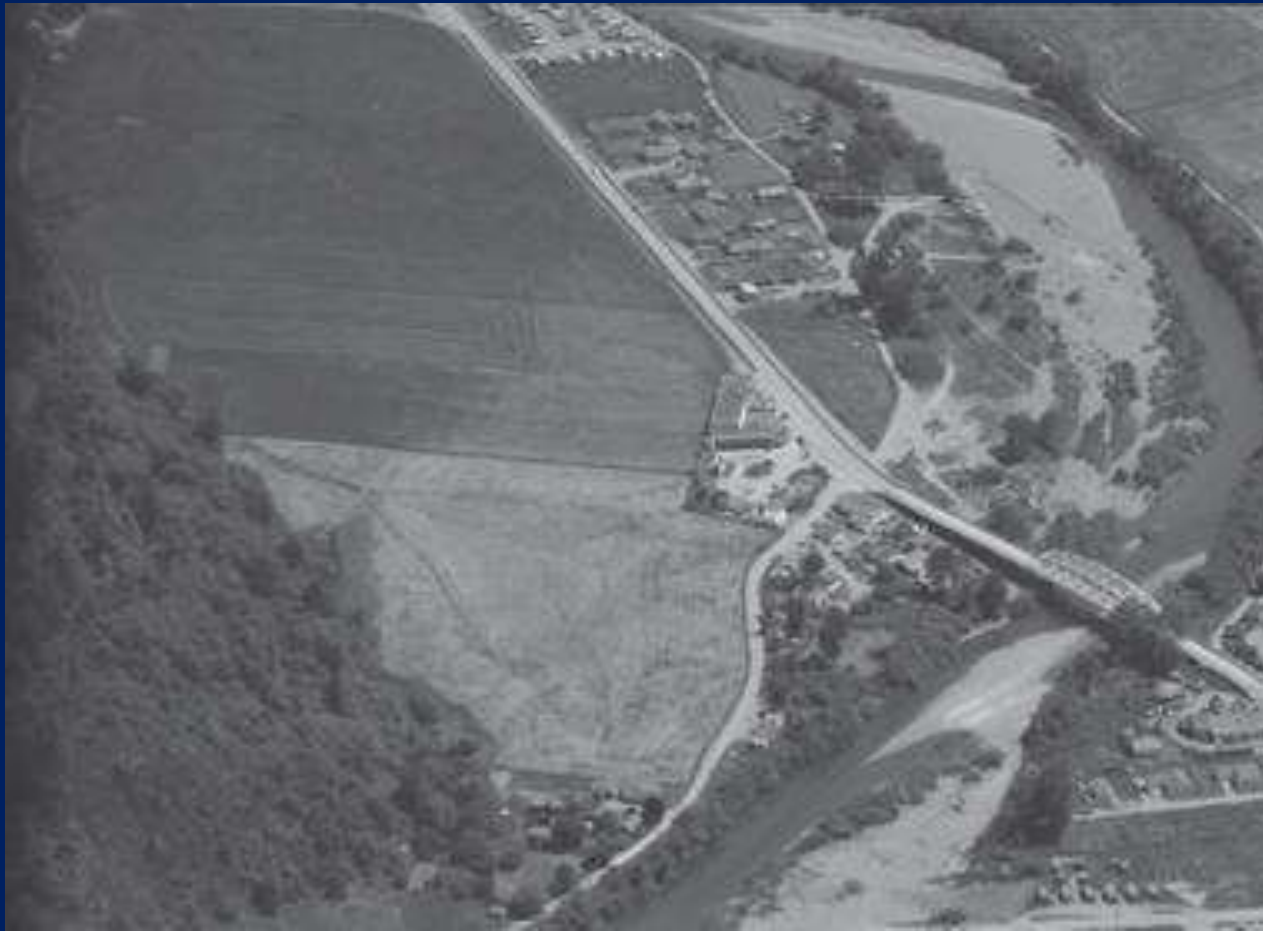
Orick 1950

Hwy 101 Bridge built ~1922, survived the 1964 flood
5200 vehicles per day

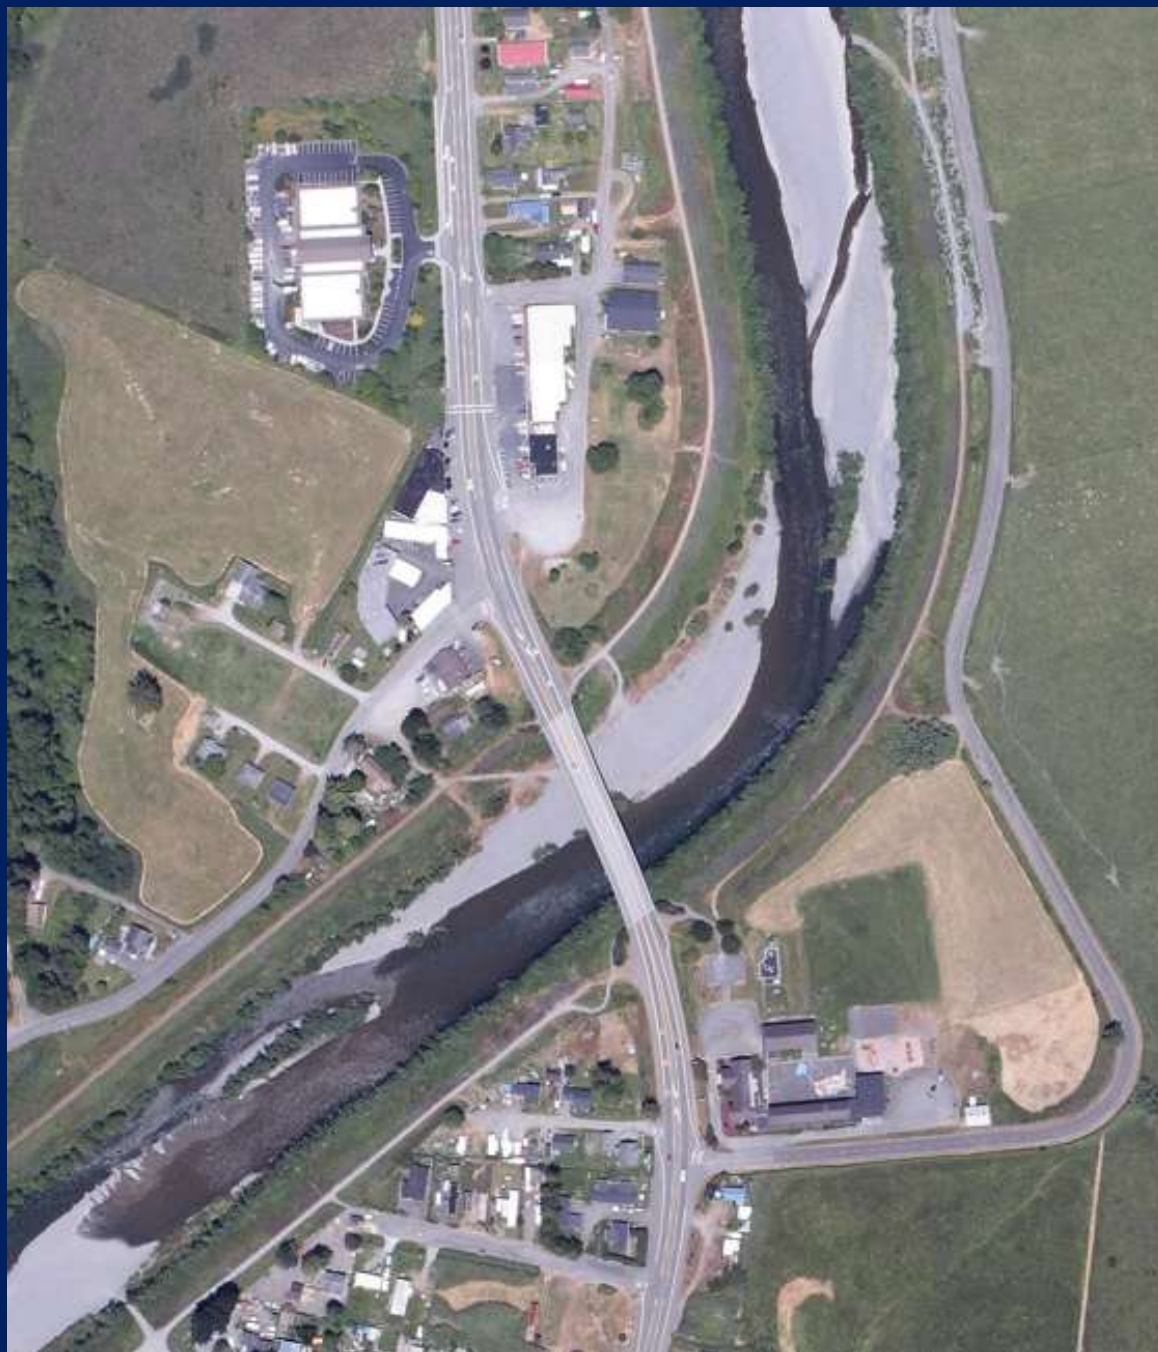
**Orick
Bridge
replaced**

New Highway 101 bridge

Abutment

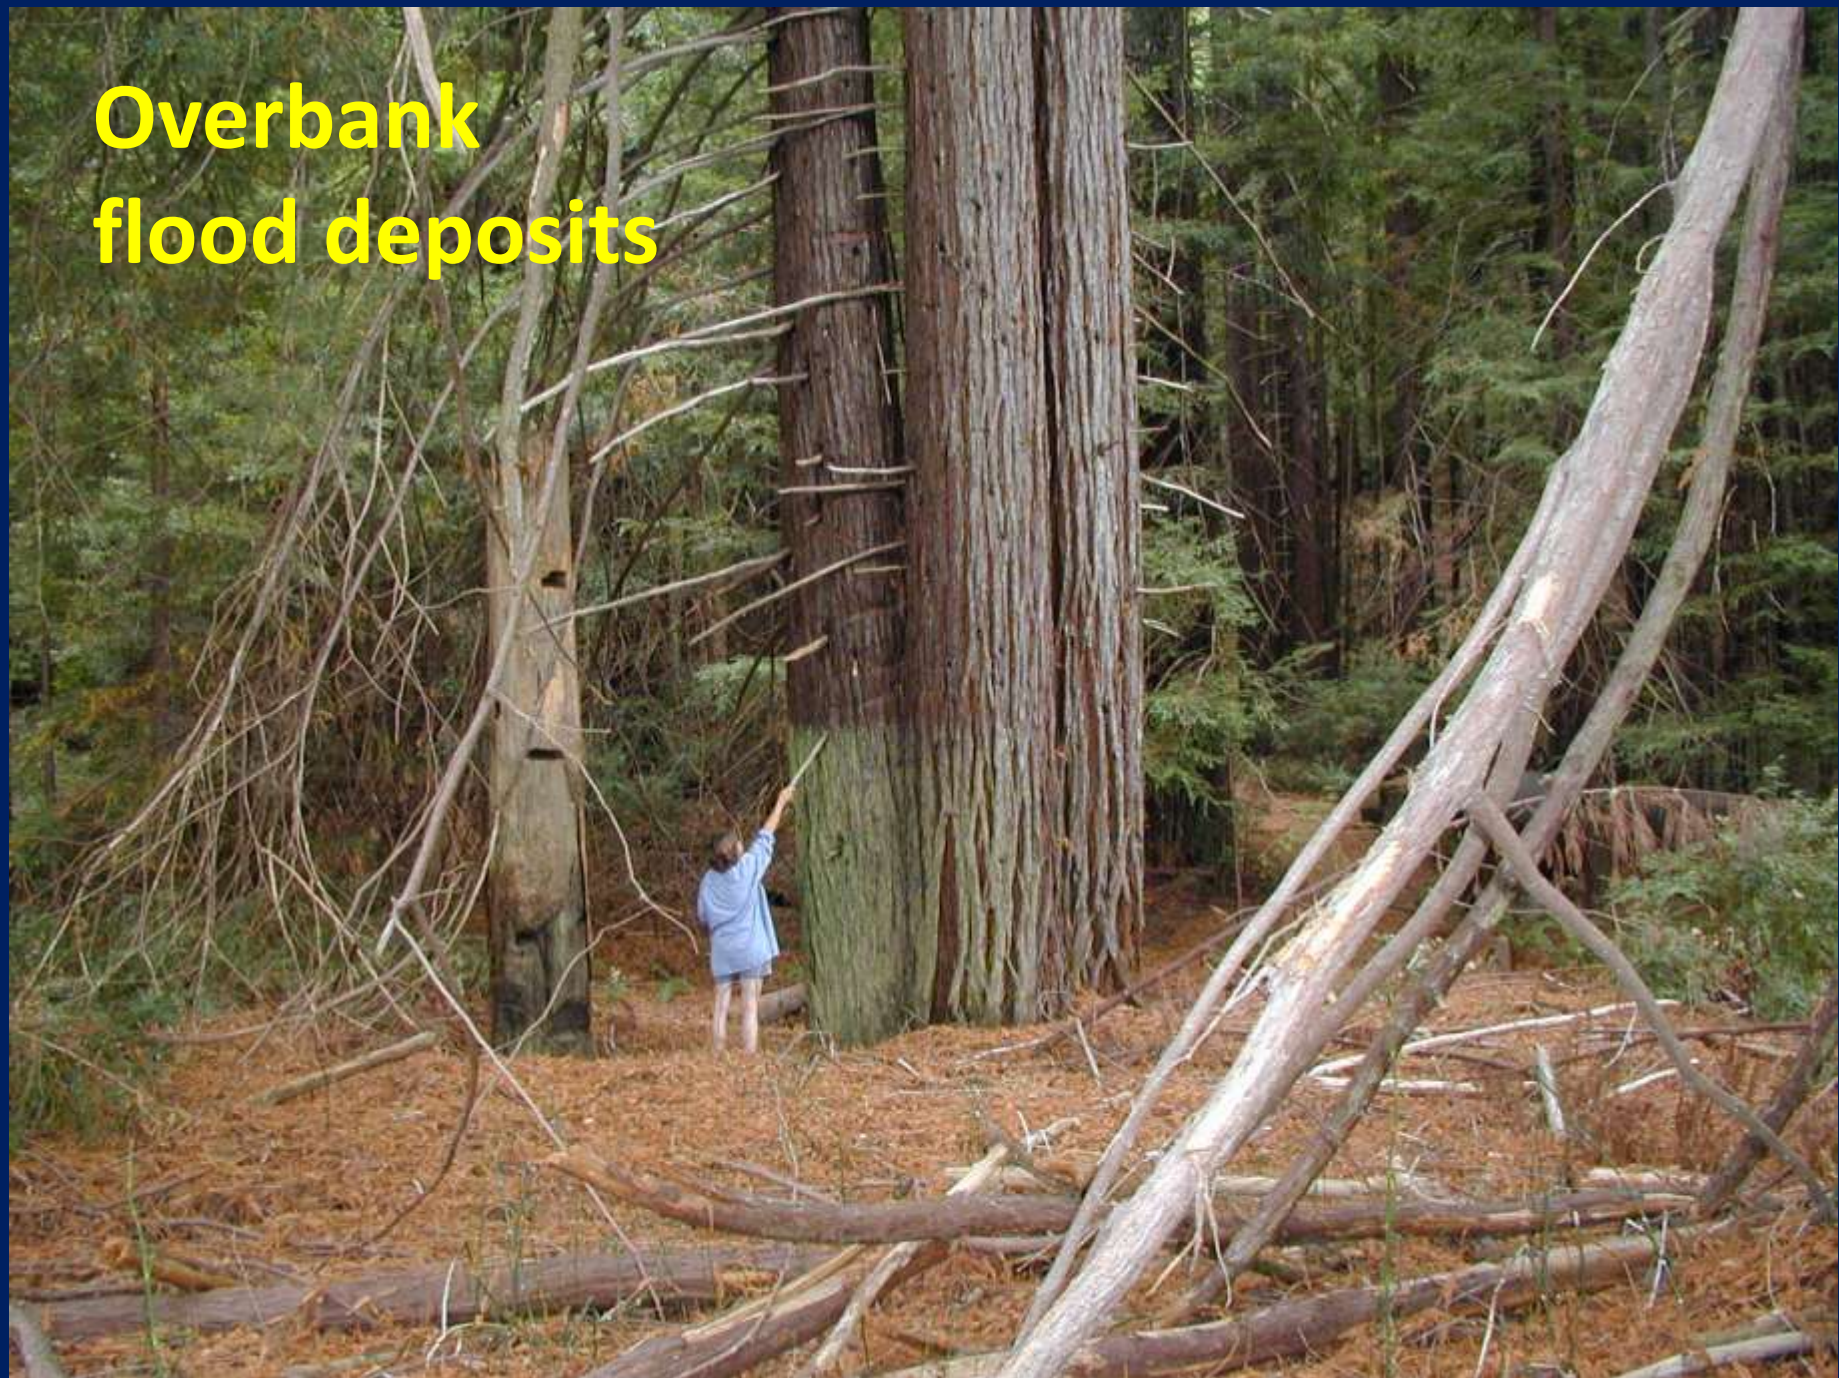
Mapping of flood deposits at Tall Trees Grove

OVERBANK FLOOD DEPOSITS, TALL TREES GROVE

Pit 2-A & Core 4

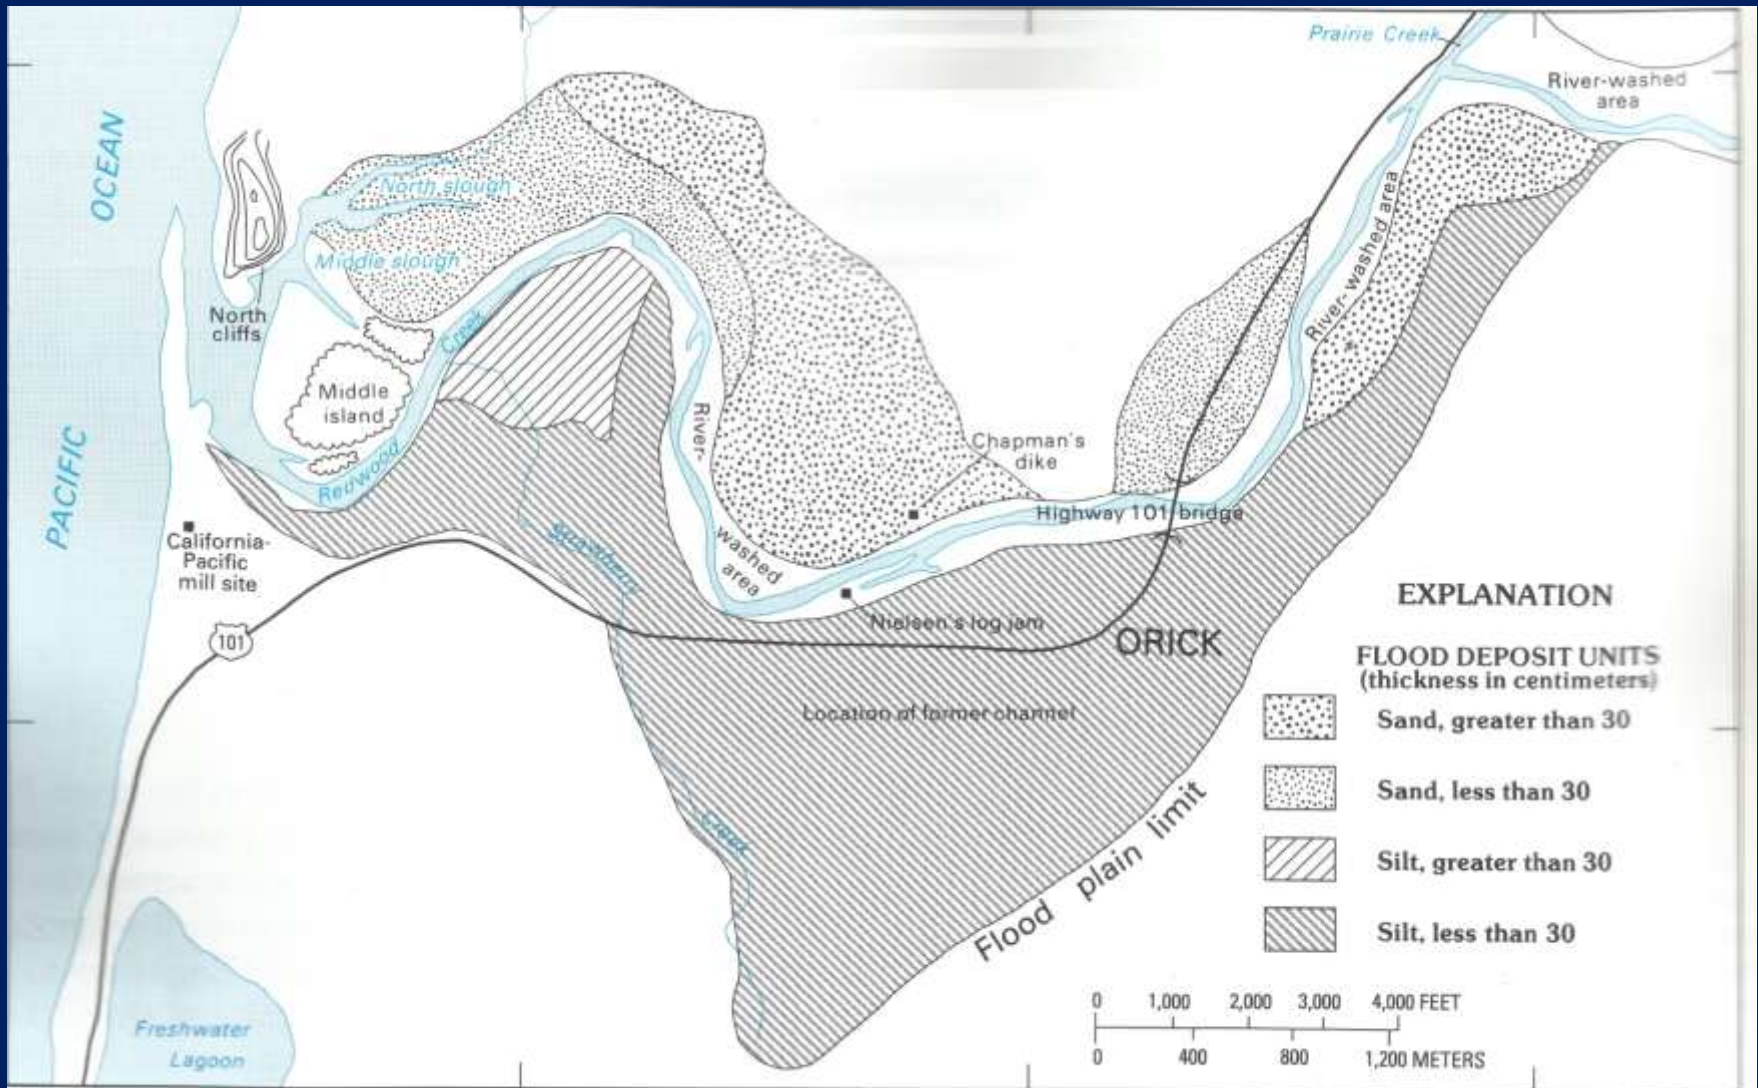
1964 Flood Deposits: Sand vs. Silt

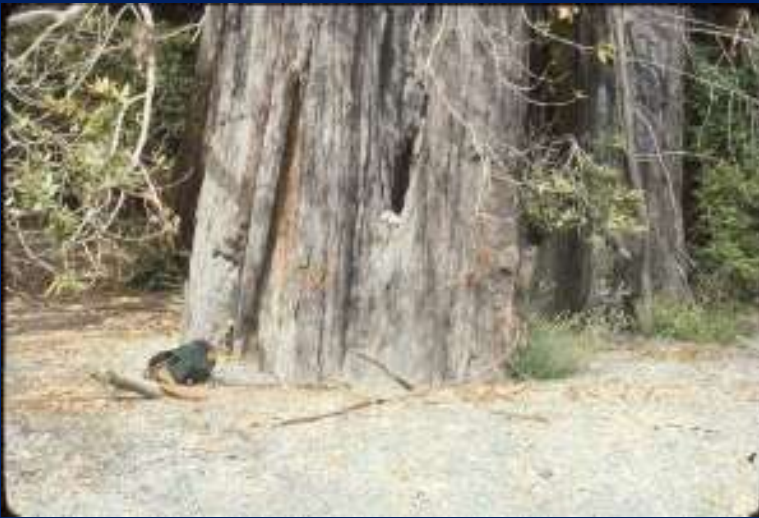
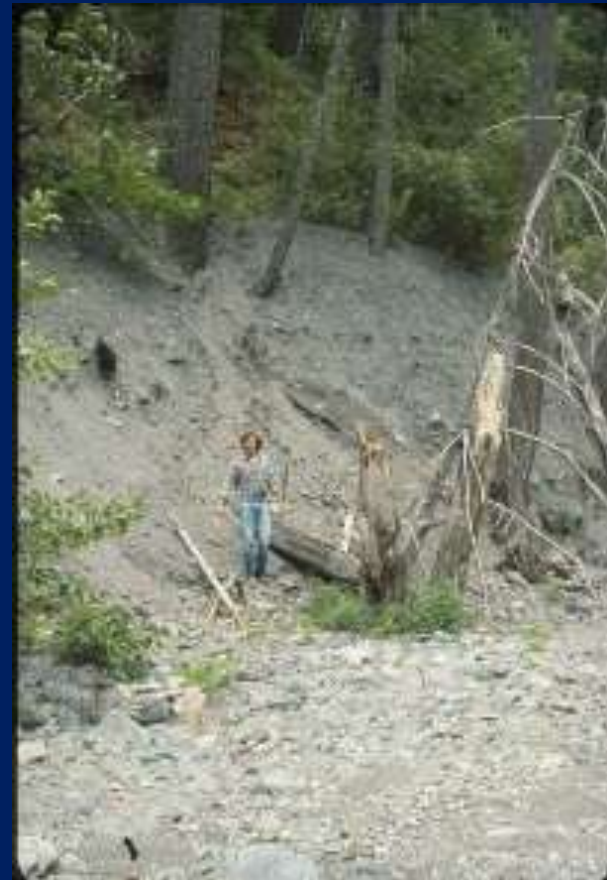
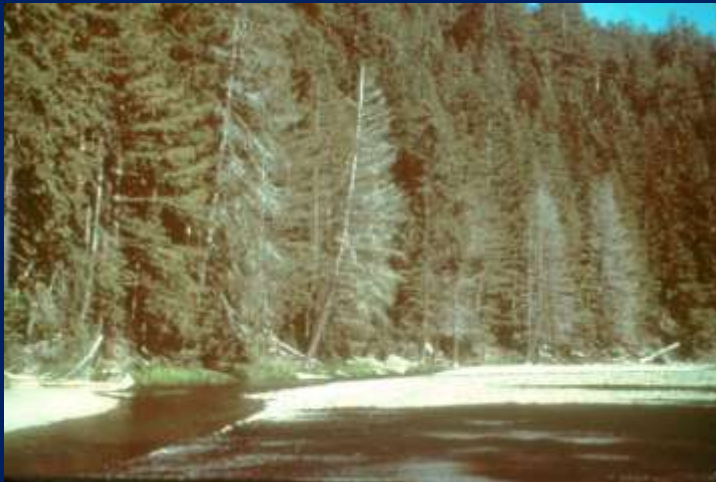
**Trees damaged by
gravel deposits**

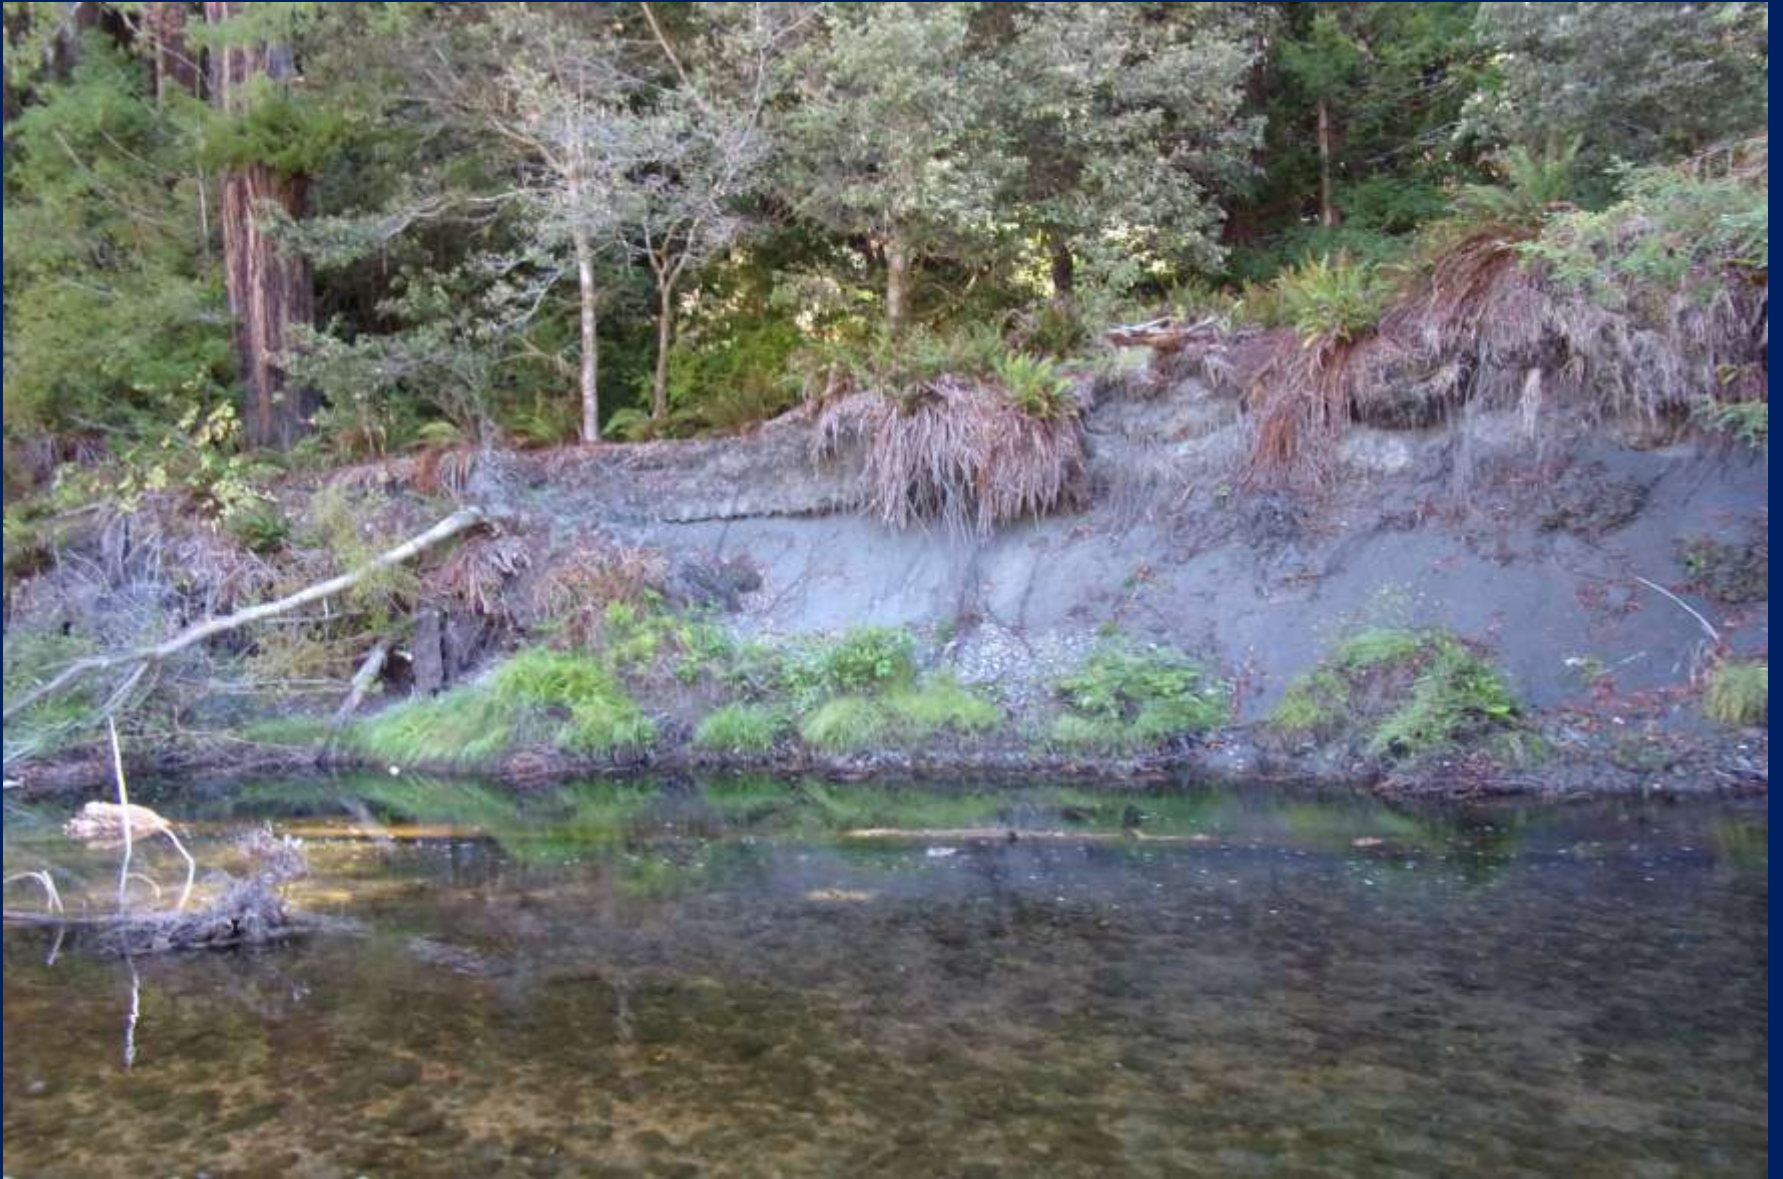
Sand deposits upstream of Elbow Slide
